# GENERALIZED HOUSING CONDITIONS MAP

Source: Generalized Housing Conditions are based on field surveys performed on a block by block basis during July 2011 through September 2011. Razed Properties are based on GIS data provided by the City of Altoona. Base GIS data provided by the City of Altoona, the Pennsylvania Department of Transportation and the United States Geological Survey.

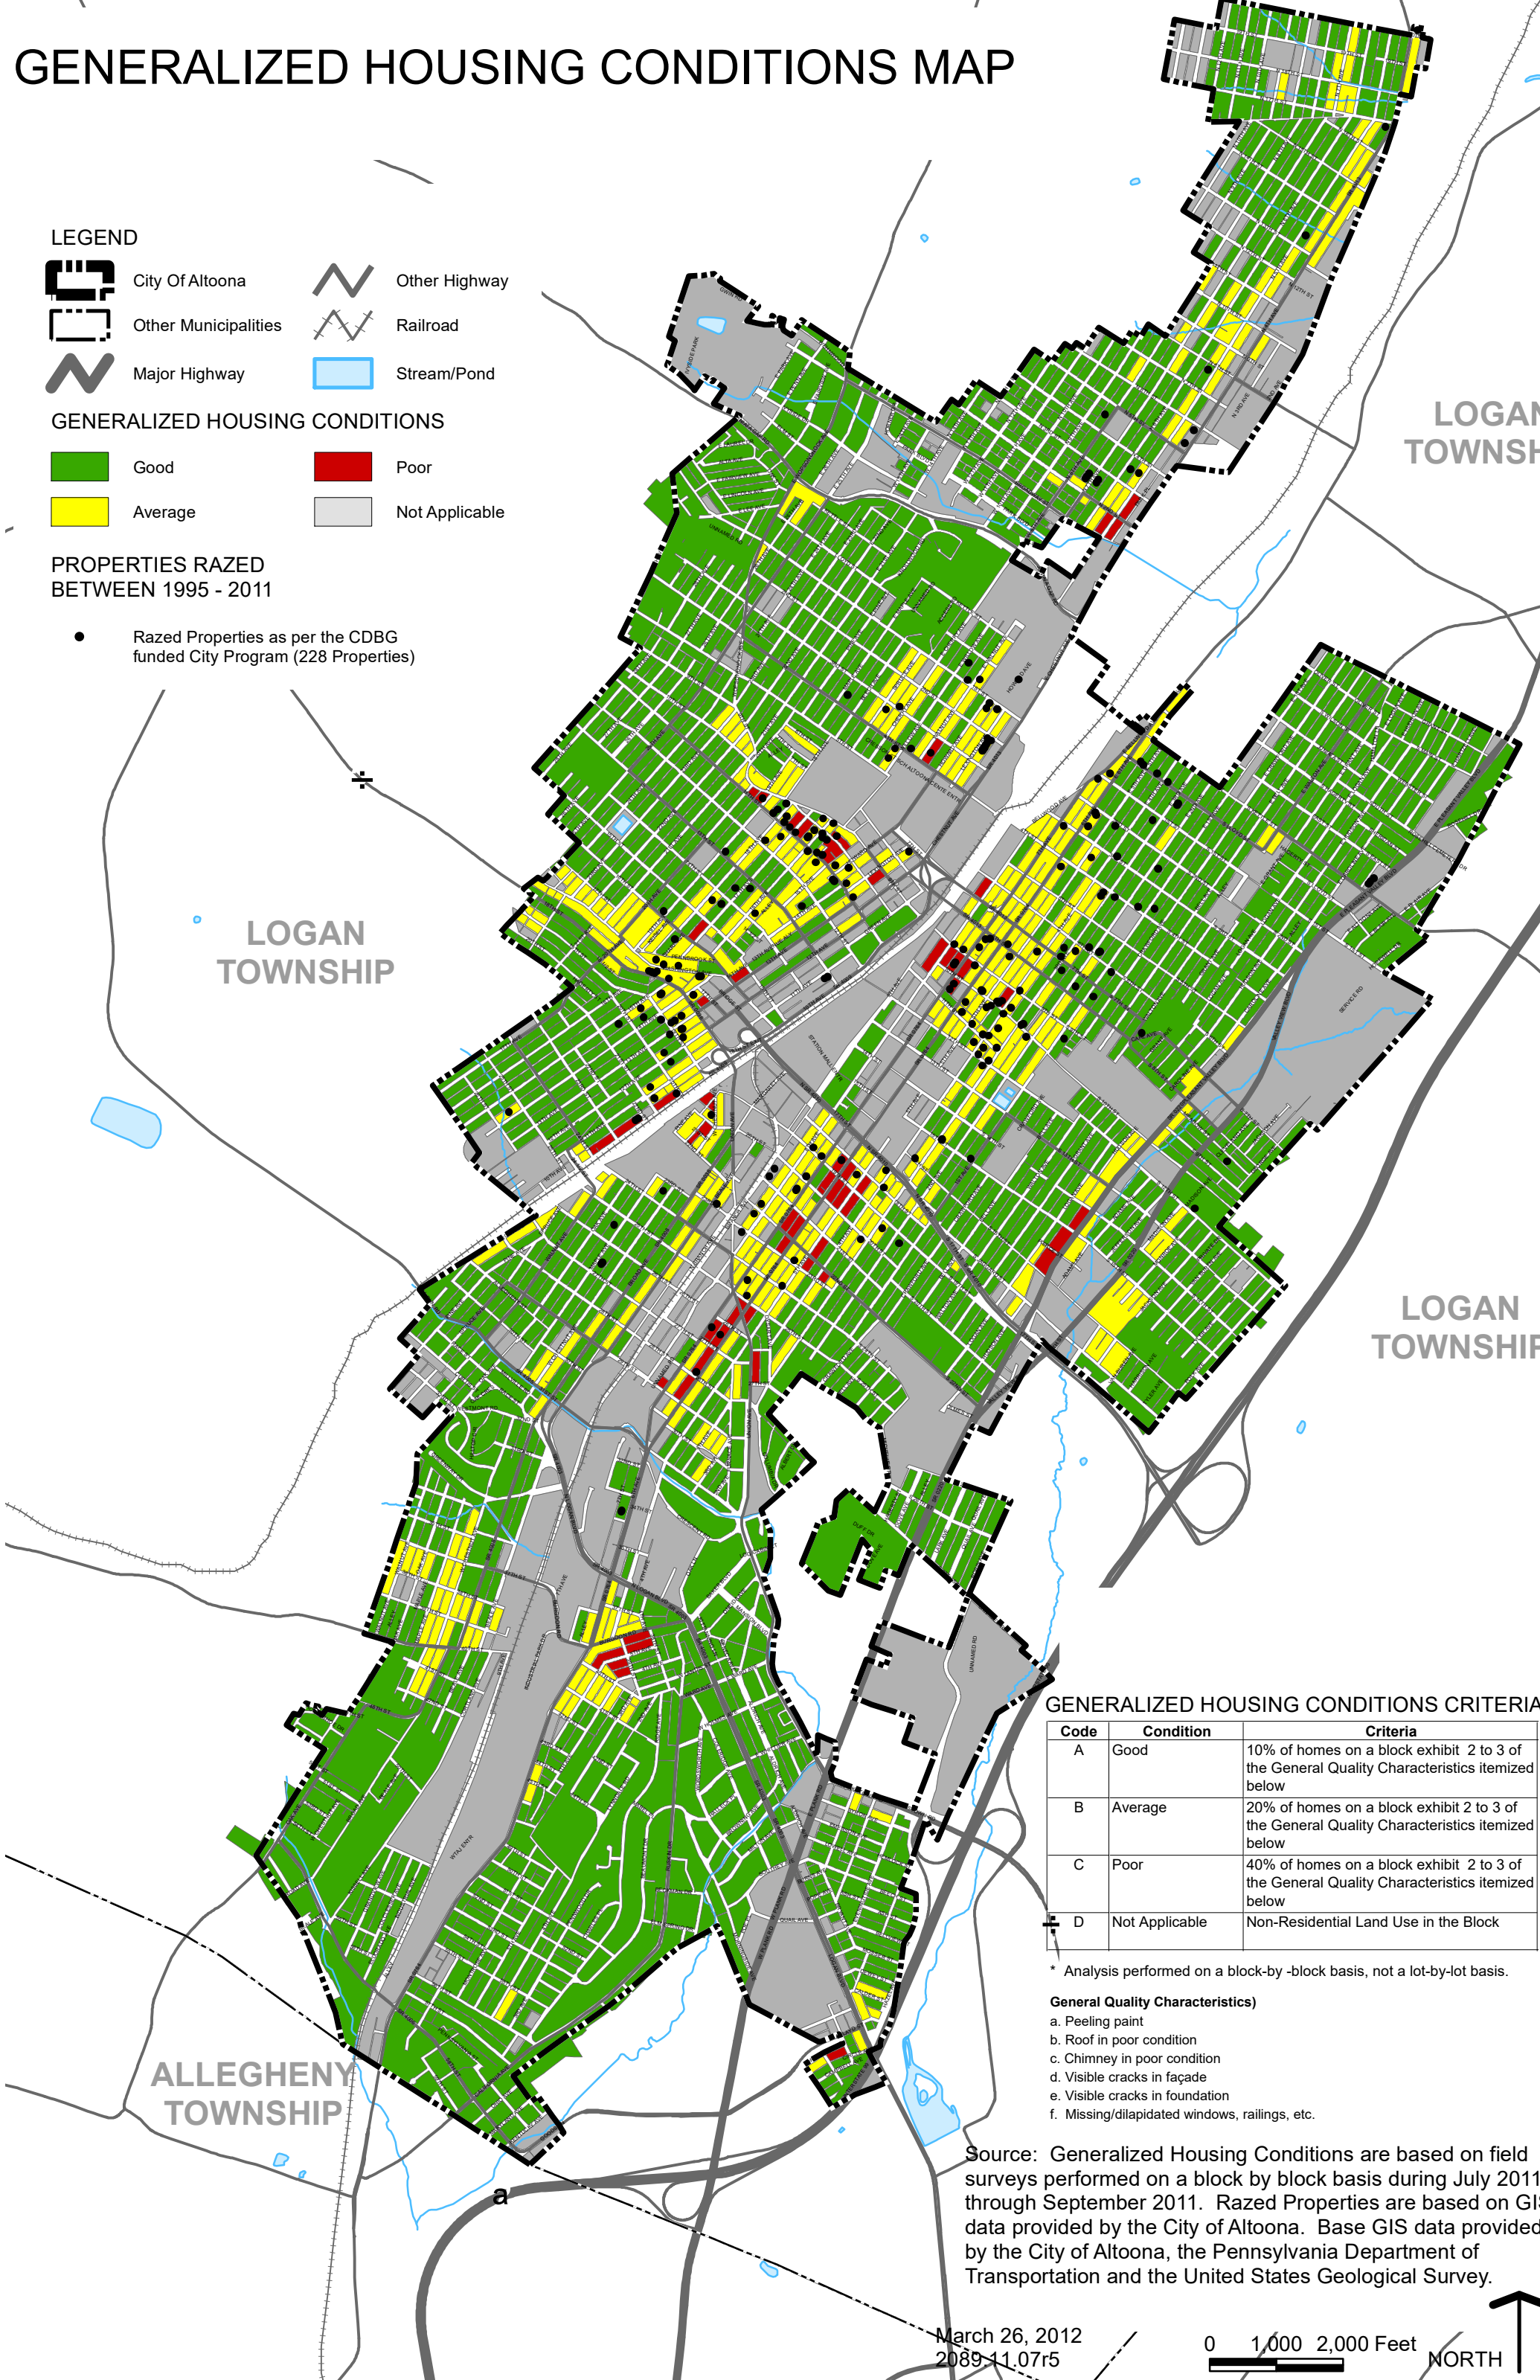
Code	Condition	Criteria
A	Good	10% of homes on a block exhibit 2 to 3 of the General Quality Characteristics itemized below
B	Average	20% of homes on a block exhibit 2 to 3 of the General Quality Characteristics itemized below
C	Poor	40% of homes on a block exhibit 2 to 3 of the General Quality Characteristics itemized below
D	Not Applicable	Non-Residential Land Use in the Block

\* Analysis performed on a block-by-block basis, not a lot-by-lot basis.

- a. Peeling paint
- b. Roof in poor condition
- c. Chimney in poor condition
- d. Visible cracks in façade
- e. Visible cracks in foundation
- f. Missing/dilapidated windows, railings, etc.
